Glenbrook North Back Gyms Floor Update

Monday, July 26, 2021

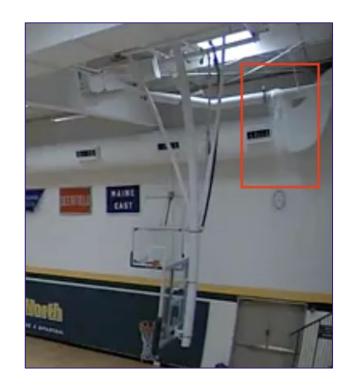
- On Saturday, June 26, 2021, around 11:15 AM, the cleanout valve of a PVC drain pipe traveling from the center roof drain, through the gym and out to the northeast retention pond burst due to excessive water pressure.

- It is assumed that the intense weather experienced that weeked resulted in an excessive amount of weather pressure that ultimately caused a cleanout valve to burst open.

Cleanout Valve on PVC Pipe that Burst

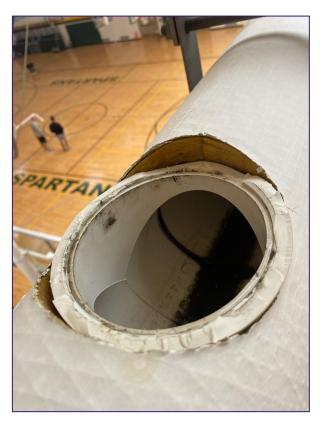
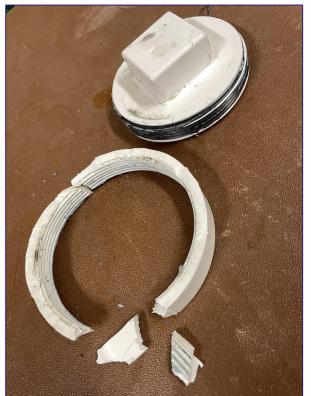
- Upon bursting, a significant amount of water fell onto the competition gymnasium floor over a period of 15 minutes and also seeped into the gymnastics gym and penetrated the vapor barrier.

- After removing portions of both the competition gym and gymnastics gym floor, it was determined that water had penetrated through the vapor barrier of approximately 60% of the competition gym floor and 10% of the gymnastics gym floor. As a result it was recommended that the full competition floor be replaced and the impacted area of the gymnastics gym (10%) be replaced and the entire floor be sanded and stained.

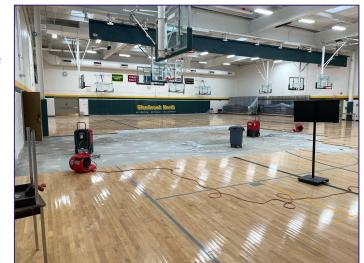
- The reason for this action is the strong likelihood of mold developing under the floor, causing additional structural and environmental damage. Without removing the vapor barrier the water cannot be effectively removed.
