**Re:** Approval of Summer 2018 Life Safety Projects

Glenbrook North High School - 2018 Life Safety Projects  
 Glenbrook High Schools District 225  
 Project No. 17044

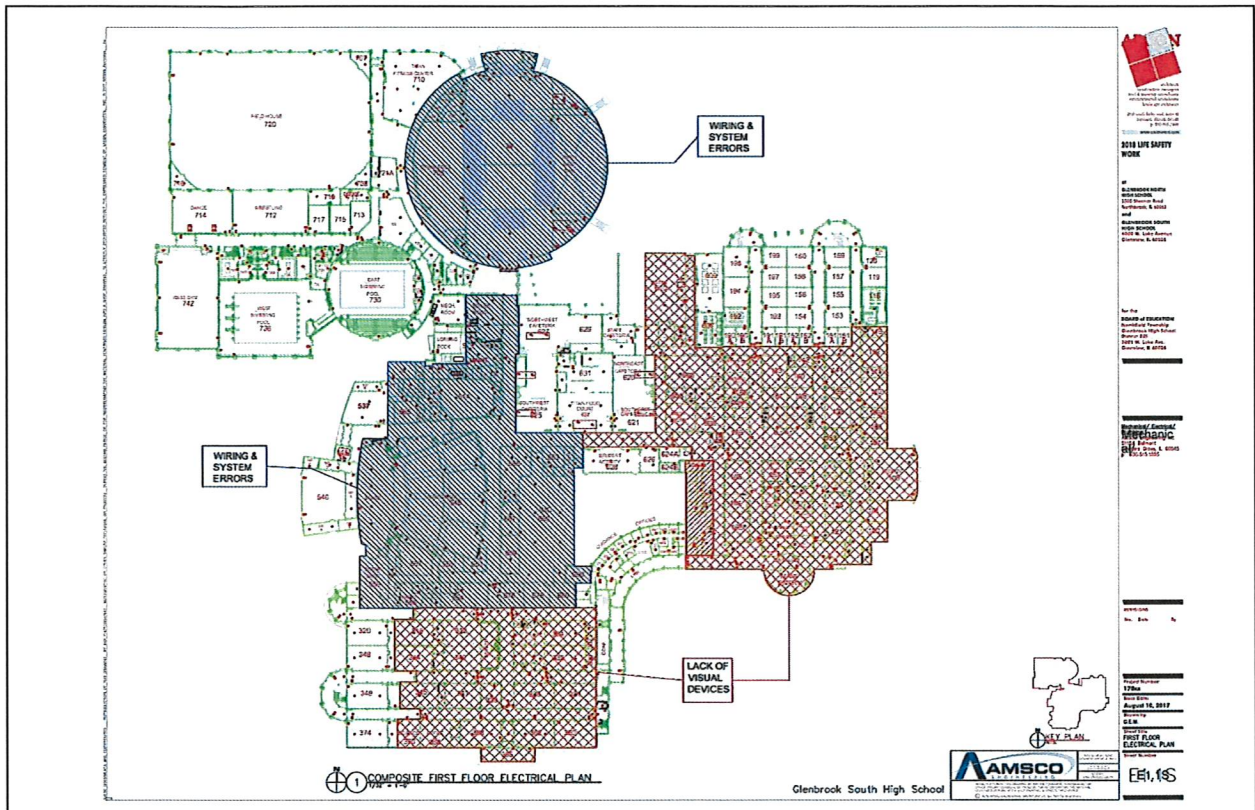
### GBS First Floor

Blue: Wiring and System Errors, Zoned Areas  
Red: Lack of Audio/Visual Devices

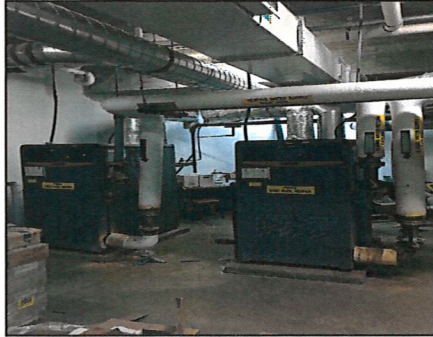
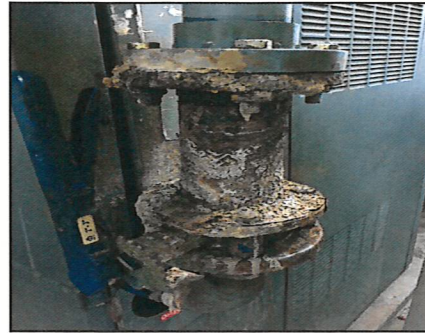
<b>Mechanical</b>		
<b>Project</b>	<b>Description</b>	<b>Estimate</b>
GBS hot Water Expansion Tank	In 2000, a new expansion tank system was installed as part of the boiler and chiller plant work. The system has been repaired several times over the years and is no longer maintaining consistent temperatures.	\$90,000
GBS Orchestra Pit Exhaust System	Due to dampness in the orchestra pit, an exhaust system is recommended to increase air flow in the pit to dry it out and reduce the chance of mold.	\$10,000
GBS Home Ec. Exhaust System	Currently, there is no exhaust system in the home economics room. This was cited during a recent ROE inspection.	\$15,000
GBS Auditorium Exhaust Grill	There is a sump pump for the sanitary line located in a closet in the basement of the auditorium that fills with sewer gas. An exhaust would relieve the smell which infiltrates into the auditorium. This project will add an exhaust grill to tie into the existing exhaust system.	\$15,000

GBS Dehumidification System Repair	The current Innovent system which provides dehumidification and temperature control in the natatorium is 8 years old and not working properly. Some of the refrigerant compressors and control valves have failed or leaked, resulting in a significant repair costs.	\$50,000
GBS Replace Pool Boilers*	The existing pool boilers were installed in 2007 and 2008. The boilers have been leaking and are approaching the end of their useful life. The pool heater being recommended has a separate heat exchanger so the chlorinated pool water does not circulate through the heater itself thus extending the life.	\$200,000
GBS Replace Rooftop Exhaust Fans	The existing rooftop exhaust fans are 30 years old and failing. The fans are required to maintain the proper static pressure in the fieldhouse along with the ventilation supply fans. Similar to the work done several years ago at GBN, intake louvers will be installed to draw in outside air and provide better ventilation.	\$70,000
