Re: Summer 2023 Capital Projects and 3-Year Master Facility Plan

Recommended Summer 2023 Capital Projects

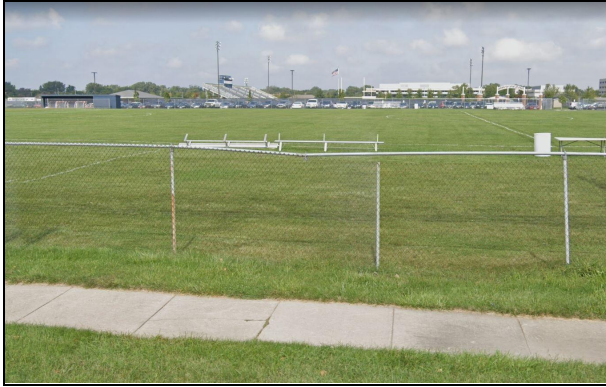
Image 1 - Existing Perimeter Fencing Along Lake (GBS)

Location(s)	Project Description	Projection
GBN GBS	<p>Perimeter Fence Replacement</p> <p>There are 2,000 linear feet of perimeter fencing along Sherman Drive at GBN and 2,650 linear feet running primarily along Lake Ave at GBS that requires replacement. The existing chain link fence is over 40 years old and rusted, and the concrete posts lift from the ground. A black vinyl-coated chain link fence is recommended. The vinyl coating helps protect the metal from scratches, rust, and corrosion and increases the fence’s durability and appearance. The new fence is expected to last 20-25 years if properly maintained.</p> <p>As part of this process, entry points will be reviewed and modified as necessary in consultation with local public safety departments.</p>	\$380,000
GBN	<p>Crackfill and Sealcoat</p> <p>The district maintains a master paving schedule that plans for parking lot replacement every 15+ years and general maintenance (crack-fill and seal coating) every four years. The scheduled summer maintenance includes the student parking lots on the north side of the building.</p>	\$75,000

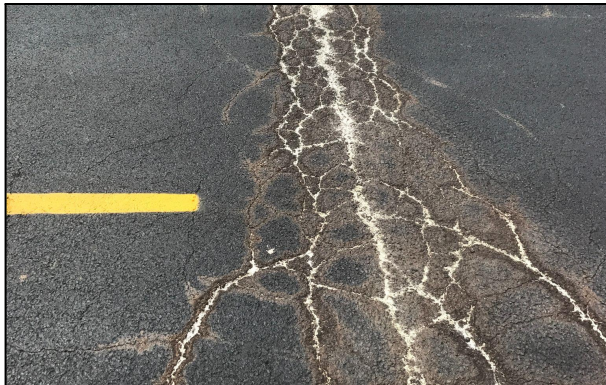
Image 5 - GBA Parking Lot

GBA	<p>Parking Lot Replacement and Sidewalk Addition</p> <p>Records indicate the parking lot at the Glenbrook Administration Building is original to the building and over 40 years old. It is well beyond its useful life and showing significant signs of deterioration, such as alligator cracks, potholes, and crumbling, consistent with a parking lot of this age. The scope of work is to remove the existing pavement surface and binder course, remove the existing stone base and retain it on-site for reinstallation. In addition, core samples are being conducted to determine the extent of new material needed to supplement the existing stone base. The curbs are also deteriorating and will be replaced with new curbing.</p> <p>Additionally, it is recommended that 320 feet of sidewalk be added along the north end of the parking lot. A high volume of students park or are dropped off east of the Pfingsten and West Lake Avenue intersection. The sidewalk will allow the students to safely walk to the GBS student entrance and avoid cutting through traffic.</p>	\$165,000

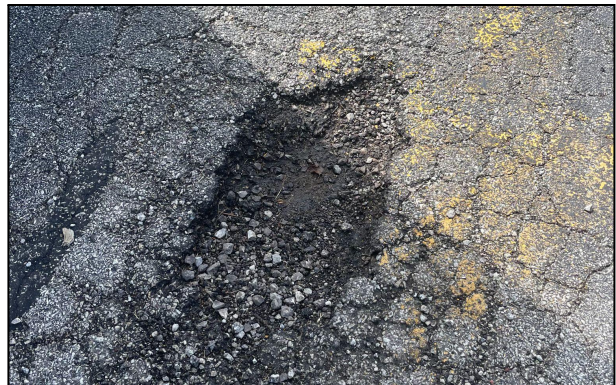
Image 6 - GBO Parking Lot

<p>GBO</p>	<p>Parking Lot Replacement</p> <p>The parking lot at the Glenbrook Off Campus building was last replaced in 2011. However, it has not held up to the heavy bus traffic. In 2011, it was replaced with “standard duty” paving (1.5” binder and 1.5” surface). It is recommended that the lot be replaced with “heavy duty” paving (3” binder and 1.5” surface) to support the regular use by full-size school buses. The lot has significant deterioration, including alligator cracks, potholes, and crumbling. The scope of work is to remove the existing pavement surface and binder course, remove the existing stone base and retain it on-site for reinstallation.</p>	<p>\$120,000</p>
		<p>\$740,000</p>

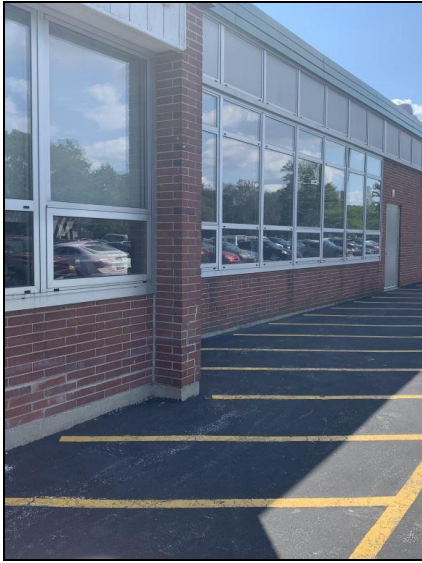
Image 4 - GBN Grinding/Tuckpointed

GBN	<p>Grinding and Tuckpointing</p> <p>The joints in the masonry wall are deteriorated and are cracking between the mortar and the brick. The cracking between the mortar and the brick can allow water to enter the wall system and lead to overall wall deterioration. The mortar joints in the identified areas should be removed to a depth of ¾” and filled with new mortar to match the color of the existing mortar. This work will keep the water out of the building and the wall system.</p>	\$75,000
GBN	<p>Wood Soffit Repair</p> <p>There are several areas around the school's perimeter where painted wood soffits are present. Numerous sections of these soffits are in deteriorated condition and require repair and painting. Painting of the wood is a repetitive maintenance item. The wood soffits will be covered with prefinished metal to improve the condition, eliminate repetitive maintenance, and improve the overall aesthetics of the building.</p>	\$35,000

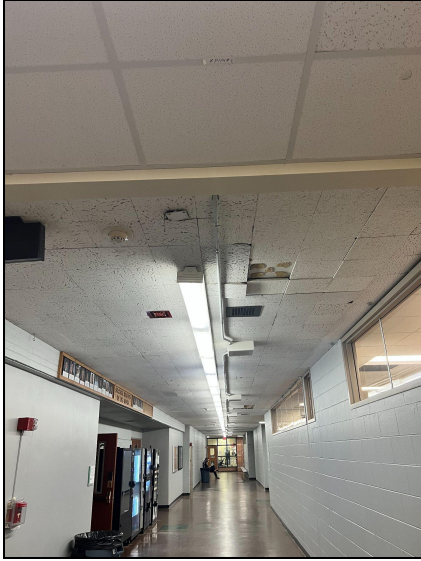
Image 1 - Back Gym Hallway

Location(s)	Project Description	Projection
GBN	<p>Corridor Ceiling, Lighting, and HVAC Work</p> <p>There are three corridors at GBN with a spline ceiling application. This is an older ceiling application that conceals the grid system using a method of interlocking panels and small strips of metal “splines.” This application requires suspended lighting and makes it challenging to remove panels to gain access without damaging the installation. Unlike a ceiling grid system, this application also doesn’t lend itself to LED lighting retrofits and makes it difficult to swap out damaged pieces.</p> <p>The three areas at GBN with this type of ceiling are the Student Activity Corridor, the Main Gym Corridor, and the Back Gym Corridor. These ceilings are recommended to be replaced with a drop grid ceiling system and LED lighting, consistent with the rest of the building.</p> <p>Additionally, the Student Activity Corridor is currently only heated with steam fin tubes along the exterior wall, and there is no cooling or fresh air ventilation. The proposed solution is to add a new Variable Refrigerant Flow (VRF) system with a single condensing unit on the roof with six small ceiling-mounted fan units placed down the hall to provide cooling and heating to the space. A recovery ventilator will be installed in an adjacent area to provide outdoor air ventilation. Controls will be added to the steam fin tubes to work with the new VRF during the heating season. As the bid specifications are being written, this solution will continue to be vetted.</p>	\$360,000

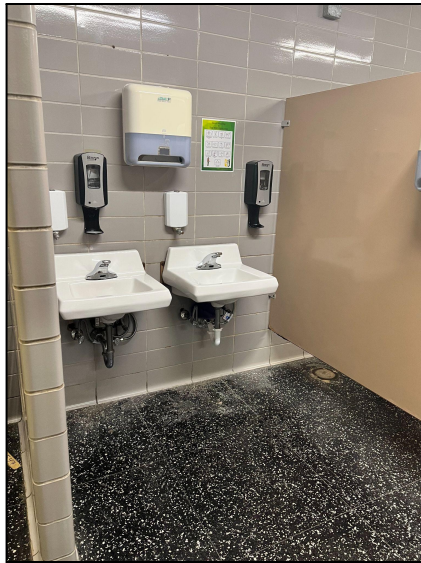
Image 1 - CTE Bathroom (GBN)

GBN GBS	<p>Student Bathroom Renovation,</p> <p>The majority of student bathrooms are original to the respective school and have not been renovated. It is recommended that a set of student bathrooms (girls/boys) be renovated at each building and a process be followed to create a district-wide standard for fixtures, tile, and lighting, balancing the overall maintenance and practicality.</p> <p>At GBN, the student bathrooms in the CTE wing are in the worst condition and are not presently ADA-compatible. At GBS, the bathrooms in the athletic wing are heavily used and need several updates. The remaining student bathrooms will be addressed as part of the Master Facility Plan.</p>	\$625,000
GBN	<p>Stage Rigging System Replacement</p> <p>GBN has a manual, counterweight rigging system that is original to the auditorium (1978). This system can lower and raise pipe battens by counterbalancing the load with an arbor loaded with counterweight (steel plates). There are (47) 71-foot-long pipe battens that run across the stage’s</p>	\$520,000

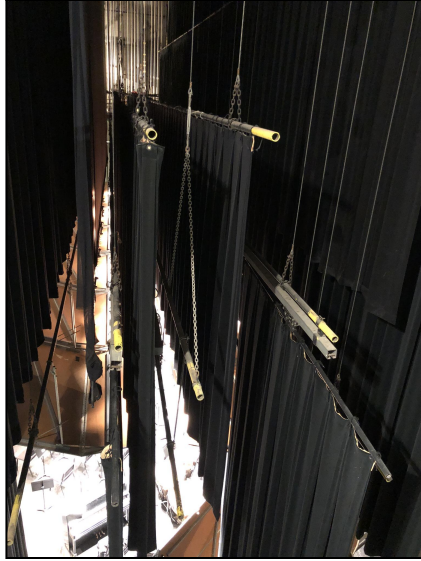
Image 2 - 71' Battens

<p>ceiling and are used to raise and lower theater equipment during a production.</p> <p>Breakout of the 47 battens:</p> <ul style="list-style-type: none"> ● 4 acoustic drapes ● 2 dead hung backstage masking tracks ● 3 full stage drapes ● 1 black scrim ● 1 cyclorama ● 3 Orchestra shells ● 3 Permanent electrics ● 9 pairs of legs and borders ● 21 Open pipes for scenery/moving light electrics/sound/electrics <p>It is recommended that the system be replaced with a newer counterweight system similar to what was installed in 2022 at GBS. The grillage will remain, but the overall number of battens will be reduced to 40, 5 of which will be motorized (3 for the orchestra ceiling panels, 1 for the main curtain, and 1 for lighting). Similar to GBS, safety locking mechanisms will be added.</p>	
<p>GBN</p>	<p>Stage Drape Replacement</p> <p>The stage curtains are original to the CPA and are of cotton construction. The drapes require cleaning and re-treating with flame retardants every five years. Over time, the fabric becomes more difficult and expensive to treat and needs to be replaced. It is recommended that the drapes be replaced with a more contemporary polyester drapery which is inherently flame retardant and does not require re-treating.</p> <p>All of the stage drapes and tracks are included in this scope:</p> <ul style="list-style-type: none"> ● Main Valance <ul style="list-style-type: none"> ○ (1) Curtain panel ● Main Curtain <ul style="list-style-type: none"> ○ (2) Curtain panels ● Traveler <ul style="list-style-type: none"> ○ (2) Curtain panels ● Tormentors <ul style="list-style-type: none"> ○ (2) Curtain panels ● Borders <ul style="list-style-type: none"> ○ (5) Curtain panels ● Legs <ul style="list-style-type: none"> ○ (10) Curtain panels ● Side Masking Curtains <ul style="list-style-type: none"> ○ (4) Curtain panels ● Scrim <ul style="list-style-type: none"> ○ (2) Curtain panels 	<p>\$190,000</p>

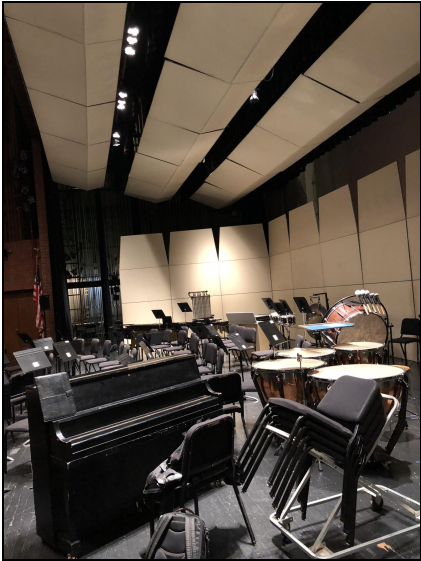
Image 4 - Orchestra Ceiling Panels

<p>The current orchestra acoustical ceiling is original to the CPA and consists of three suspended panels. The panels are lowered to form a “ceiling” above the orchestra to reflect the sound. The panels are heavy and show signs of age, such as failing hardware. Since the rigging system supports the ceiling panels, it is recommended that they be replaced. An added benefit of the newer acoustical ceilings is the panels carry their own LED lighting.</p>	
GBN	<p>Stage Floor Replacement The existing hardwood stage floor is 4,800 square feet, is original to the auditorium and has worn from the various stage sets screwed into the base over time. There are numerous weak spots and a great deal of deflection underfoot. Additionally, there is significant splintering, shearing, and the potential for failure under heavy loads. The floor sits on a sleeper system which will be replaced as part of the project.</p> <p>The existing floor is recommended to be replaced with the plyron flooring system used at GBS this past summer. Plyron is constructed with a hardboard face that is laminated to a plywood substrate and is available in 4’x8’ panels. It is a popular application for stage floors that require a hard, durable surface and enables set pieces to be secured to the floor without damaging the surface. After installation, this product is painted black and can be repainted as needed. The product has a 20+ year life expectancy.</p>	\$140,000

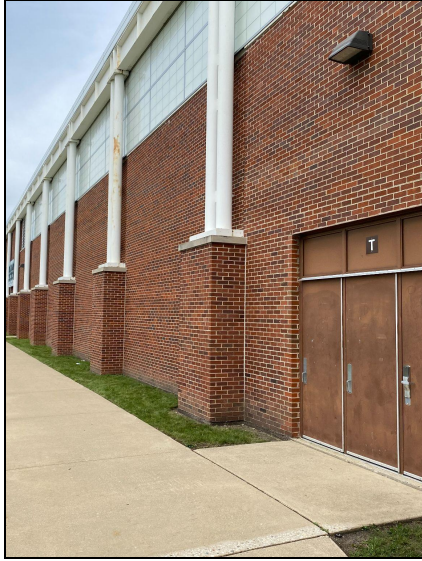
Image 1 - Fieldhouse Columns (GBN)

GBN	<p>Fieldhouse Steel Column Painting The steel columns and metal bases around the exterior of the fieldhouse are crumbling and require repair. It is recommended that prefinished metal flashing be installed at the bases and the steel columns be prepped and painted.</p>	\$50,000
GBS	<p>Lyceum Repair Work The exterior wall finish of the Lyceum is in deteriorated condition and requires repair. A Direct Applied Finish System is recommended for the exterior of the Lyceum. The application is a ready-mix, acrylic-based exterior textured wall finish. This system will not require regular maintenance of painting.</p>	\$45,000
		\$2,110,000
