Re: Recommended Summer 2019 Capital Projects

Recommended Summer 2019 Capital Projects Page 3

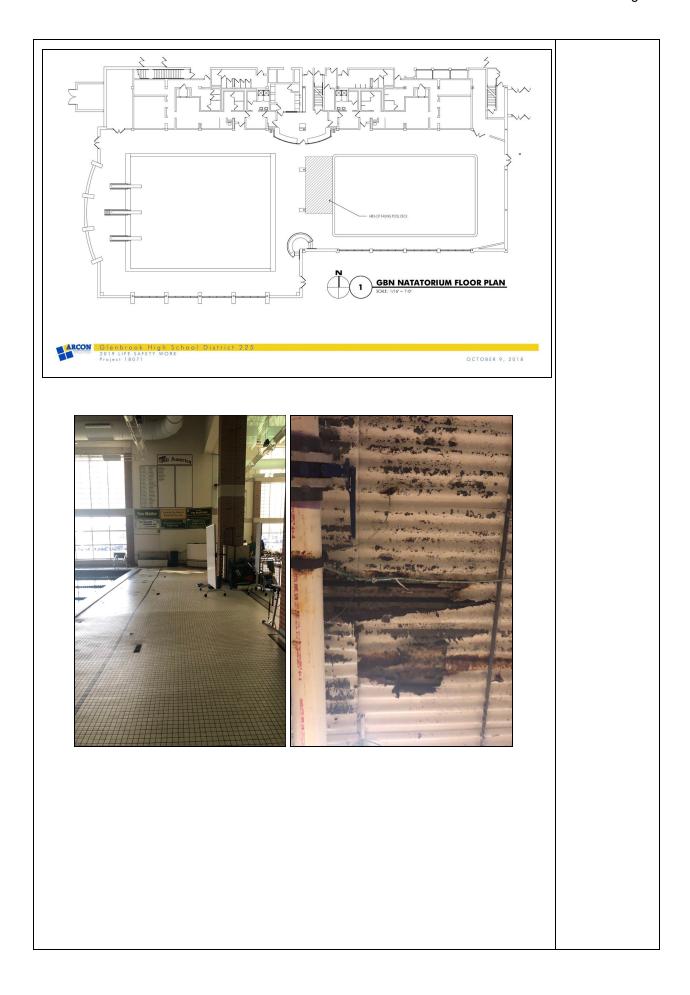
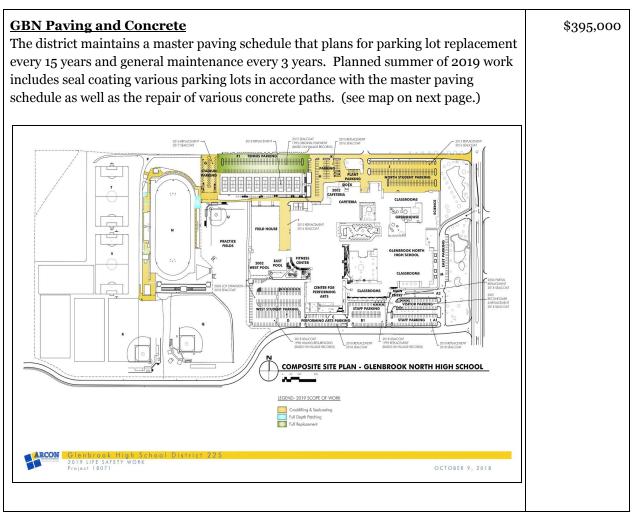
GBN Pool Deck Repair The original concrete pool deck was installed in 1957 using a 1" corrugated metal form deck. The deck provided a form for the bottom side of the structural slab to support the weight of the wet concrete and should have been removed after the concrete had set and cured. It has most likely been trapping the humidity and concrete gas from the room directly below the pool deck which is the mechanical room. Over time the metal rebar has rusted and is spalling the bottom side of the concrete slab which impacts the long-term structural integrity.	\$345,000
The corrugated metal deck and all associated pipe work will need to be removed. A wood formwork will be constructed within the mechanical room 8" lower than the bottom side of existing deck. Rebar will be placed and self consolidating concrete will be pumped through drill holes from the pool deck. Temporary shoring (i.e. temporary posts and beams) has been installed as a safety precaution.
