**Re:** Recommended Summer 2019 Capital Projects

<b>Project Descriptions</b>	
<b>Project and Description</b>	<b>Estimate</b>
<p><b><u>Ceiling Painting</u></b>                      The natatorium ceiling was last painted in 2001 when the larger pool was constructed. Since the painting of the existing ceiling and structure require the pools to be drained, it's the opportune time to perform this maintenance activity in conjunction with other pool work being performed as part of life safety work. The paint will help preserve the integrity of the existing deck and structure. The scope of work includes the cleaning and preparation of the existing metal deck and joists, priming of areas for application of new paint, and painting of all surfaces and appurtenances with two coats of finish.</p> <div style="display: flex; justify-content: space-around;">

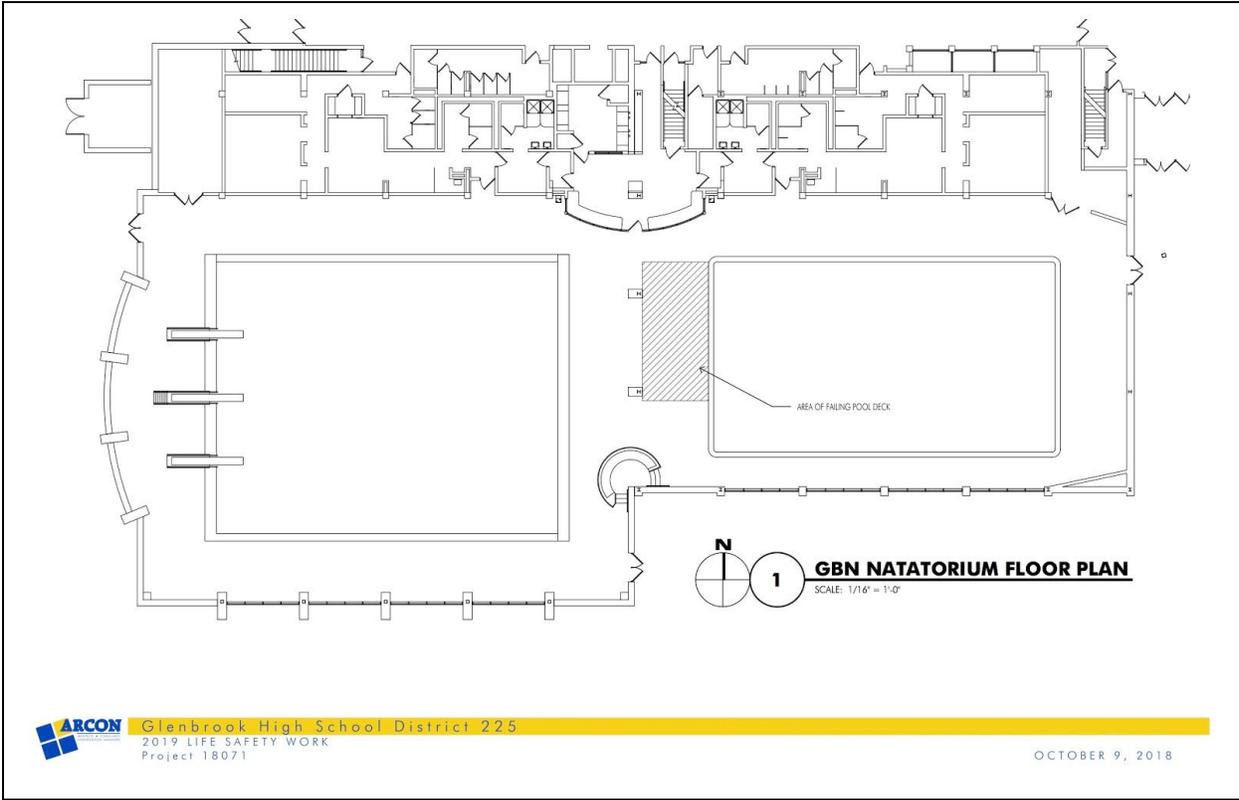
# Overview Map of Projects Requiring Additional Research

Project and Description	Estimate
<p><b><u>GBN Pool Deck Repair</u></b></p> <p>The original concrete pool deck was installed in 1957 using a corrugated metal form deck. The deck provided a form for the bottom side of the structural slab to support the weight of the wet concrete and should have been removed after the concrete had set and cured. It has most likely been trapping the humidity and concrete gas from the room directly below the pool deck which is the mechanical room. Over time the metal rebar has rusted and is spalling the bottom side of the concrete slab which impacts the long-term structural integrity.</p> <p>The corrugated metal deck needs to be removed to understand the extent of damage to the concrete and rebar sitting above the metal deck. Since it is unknown to what degree the suspended concrete has been jeopardized, temporary shoring (i.e. temporary posts and beams) is being installed as a safety precaution.</p>	<p>\$130,000</p>
